Elevating and Amusement Devices Safety Program	Ref. No.: 302 / 23
DIRECTOR'S SAFETY ORDER	Date: May 18, 2023

Re: Bearings on all Dover-Turnbull Counterweights with 2 to 1 Roping

TKE FIELD BULLETIN 3 JANUARY 2023

Subject: Counterweight assemblies with 2:1 roping.

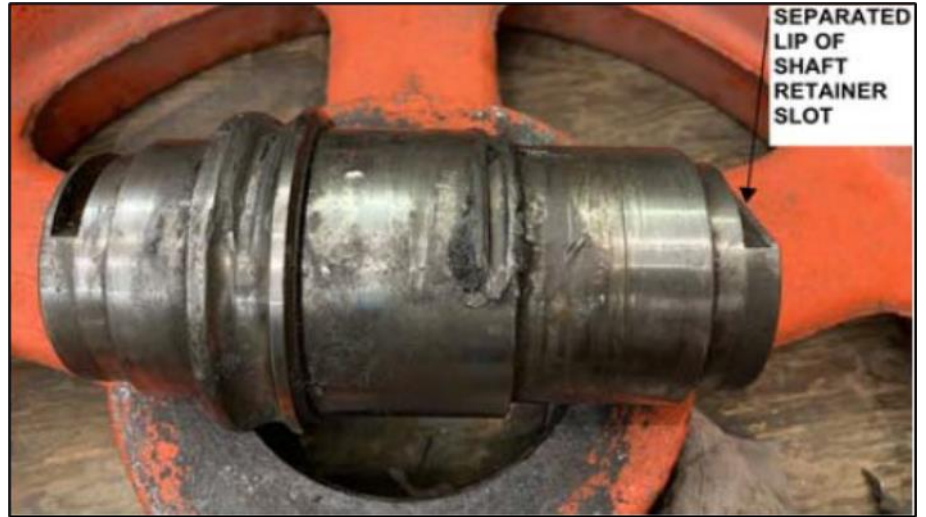
- If there is an inspection hole on the sheave retainer plates, look through the hole at the bearing.

Most Bearings are sealed and lubricated for the life of the bearing. On good bearing the grease retainer shield must be intact, and no grease should be observed coming out of the bearing.

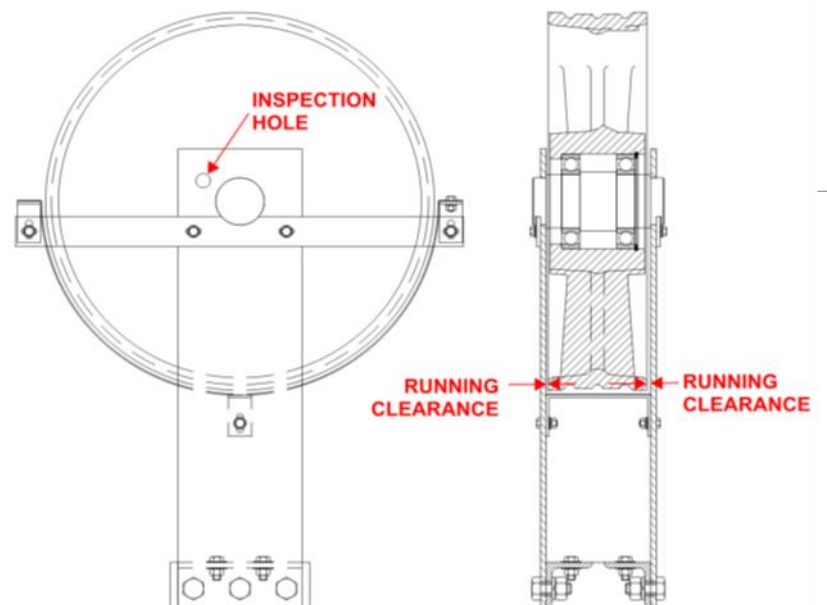
- Check the running clearance of the sheave outer rim against inner side of both retaining plates. See the diagram on the following page.

The running clearances on the front and back of the sheave should be the same dimension, different clearance may indicate bearing wear.

If there are items of concern.
Leave the car shutdown and contact your supervisor.

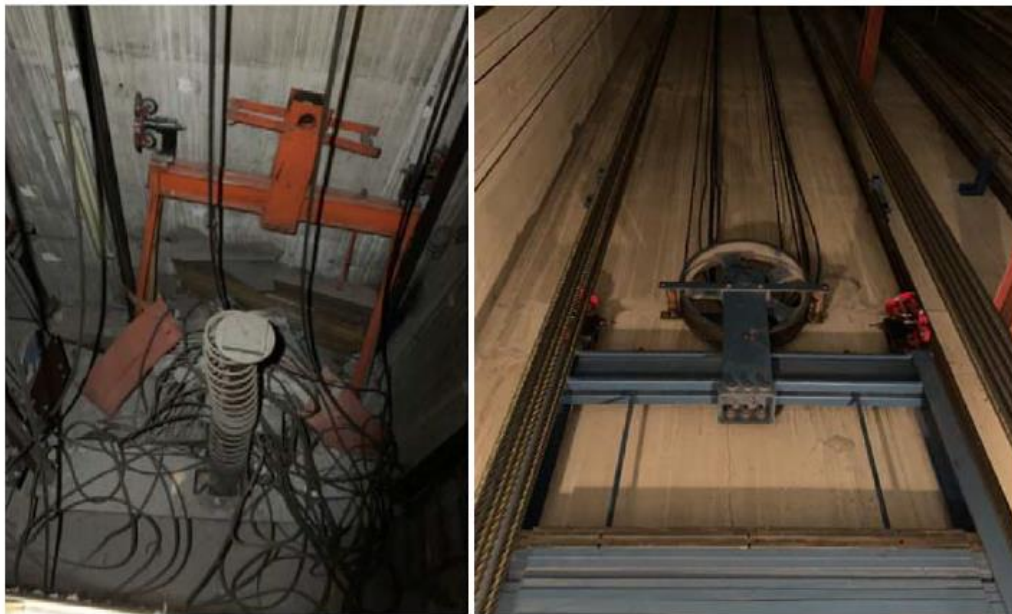
FIG 1 – Failure examples

Description: There is a possibility of a catastrophic failure when a counterweight sheave bearing fails and causes the sheave to seize and potentially cause the ropes to come off the sheave. Early detection of a possible failure is essential. In an extreme case the seized sheave will tilt and cause excessive force to be applied to the counterweight cheek plates, detaching the sheave and ropes from the CWT assembly which in turn would cause the counterweight and car to fall down the elevator shaft. There have been cases where the bearing failure has gone unnoticed, these scenarios have occurred on some Turnbull-Dover counterweights.

In both cases above the bearings failed on a unit manufactured by Turnbull – Dover, with 2:1 roping, where the sheave fixing arrangement failed which should have kept the pulley shaft in position even in case of bearing fracture.

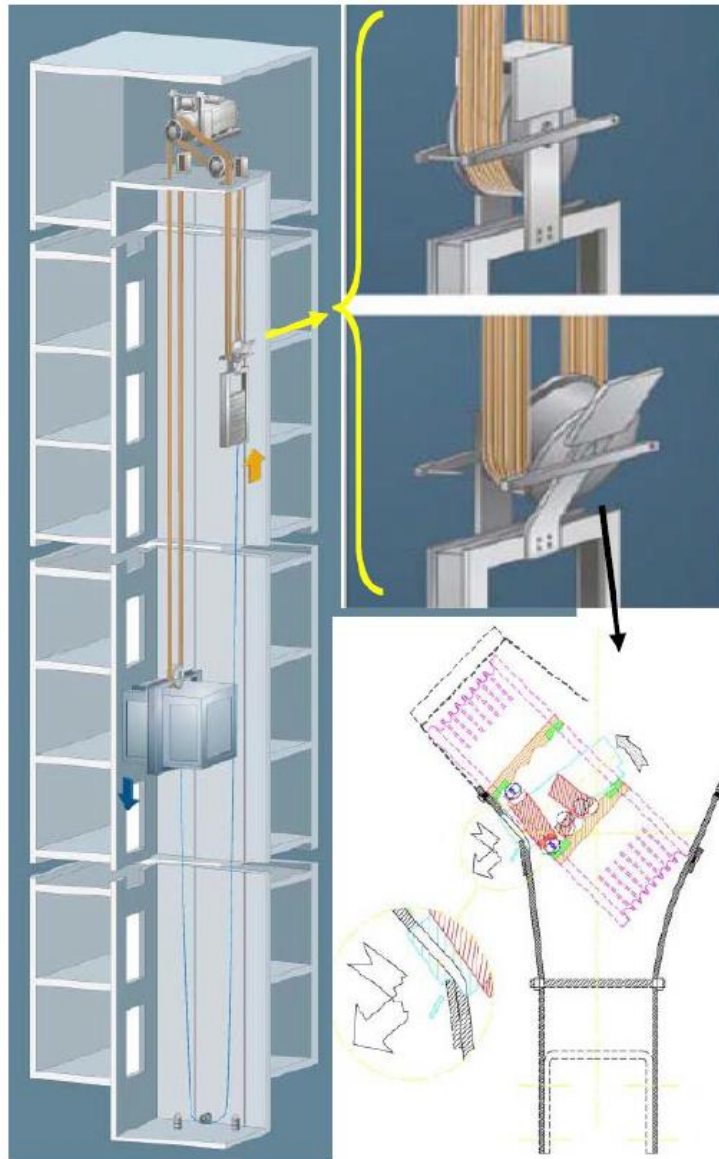
Figure 1: Illustration of bearing failure

The counterweight sheave shaft bearing can fail due to excessive service life, overload stress or lack of lubrication. The counterweight sheave would then jam on the counterweight shaft. The counterweight sheave is then on an angle placing pressure on the cheek plates which connect the counterweight to the counterweight sheave. This pressure can cause the shaft retaining means to fail and the sheave to separate from the counterweight, possibly resulting in the car being in a free fall condition activating the car safety gear in its most severe operating condition.

In the noted incident the bearings which failed were SKF-6218 sealed bearings which cannot be lubricated and were used on some Dover-Turnbull counterweights. Engineering calculations, based upon SKF data indicate the bearing service life should not exceed 27,000 hours. The life will vary depending on the duty cycle of the installation.

Enforcing regular inspections of all CWT sheave bearings has now been mandated by TKE and this task added to the MCP. This advisory is to inform the industry of this initiative as a means to mitigate risk of any sealed bearing failure in particular those on the counterweight sheaves.

TKE have also designed a retrofit kit to replace the sheave shaft and bearings. The retrofit kit also includes additional rope retainers to mimic the seismic requirements which prevent the hoist ropes from jumping off the sheave. This is now more relevant now that full speed, full load buffer and safety tests are mandatory which apply further stresses to the system.

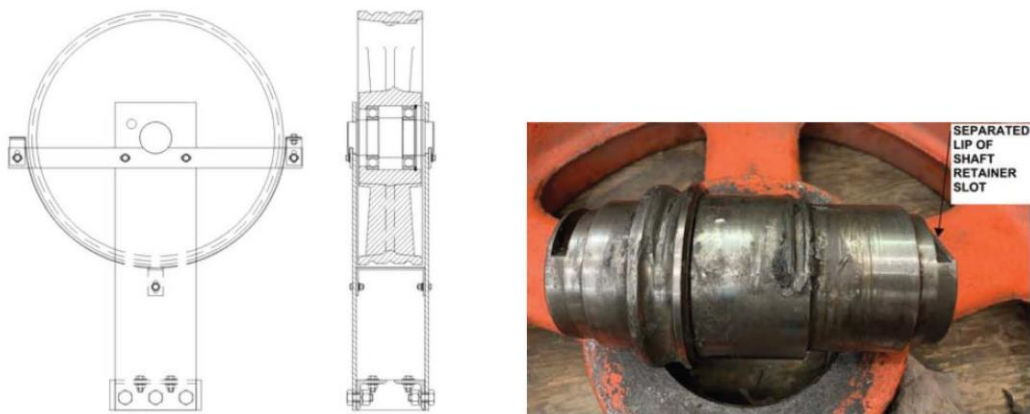
During normal elevator operation the counterweight (CWT) idler sheave separated off the CWT frame. CWT frame fell into the pit. CWT idler sheave fell on the car roof, penetrated through it and landed on cab floor. Car safeties applied stopping the car from a free fall.

The root cause of an incident is the failure of CWT idler sheave bearings. One of inner bearing rings got worn faster than the other allowing the outer ring with roller cage to relocate towards the center of the sheave shaft. Subsequent shaft wear allowed the sheave to skew out of plumb. Sheave started applying horizontal force on side retainer plates and on the lip of shaft retainer slot. The lip of shaft retainer slot snapped off and one side of the shaft dislodged from retainer plate making the sheave to separate off the CWT frame.

Method of preventing such accidents is periodic checks and replacement of sheave bearings. Note that bearings in this sheave design are sealed, lubricated for life, and cannot be lubricated. Bearing life span depends on use. Signs of bearing failure are vibration and noise.
