Elevating and Amusement Devices Safety Program	Ref. No.: 278-19
ADVISORY	Date: May 15, 2019

Subject: Otis Brake Lever for 130, 131, 139 and 156 series Gearless Machines
Distribution: Posted on TSSA website

Gearless Machine Brake Lever

ID 2019-01
Page 1
January 1, 2019

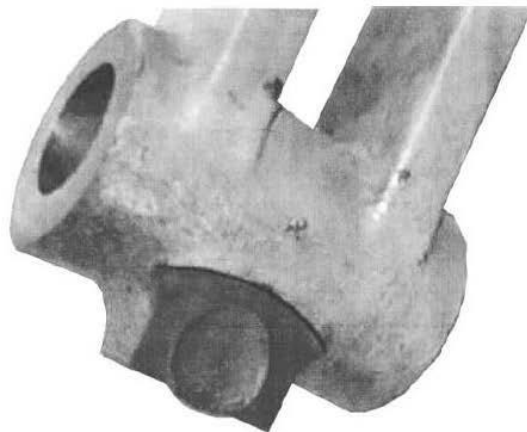
Otis has determined that the ductile iron brake lever used on 130, 131, 139 and 156 series gearless machines is subject to wear, typically over a period of years, at the point it contacts the hardened lift pion. The wear may compound in arrangements using an O-ring isolated lift pin. This wear is a maintenance issue that will be evident to the mechanic conducting the required inspections and maintenance. The wear may be more pronounced on units installed to comply with B44/CEN where each brake shoe is required to hold 125% of the duty load.

Figure 1: Brake Lever with Wear

Regular maintenance as required by A17.1/B44 8.6.4.6 should include examination of bearing surfaces for accumulated wear. Excessive wear at this point may prevent the brake arm from fully lifting the shoe with the potential to compromise the brake's holding efficiency.

If the wear exceeds 1/16th inch (1.6 mm) in depth, the brake lever should be replaced. Replacement ductile iron brake levers available from Unitec Parts have been redesigned and are now furnished with a hardened steel bearing button at the point of impact. Brake levers should be replaced in pairs.

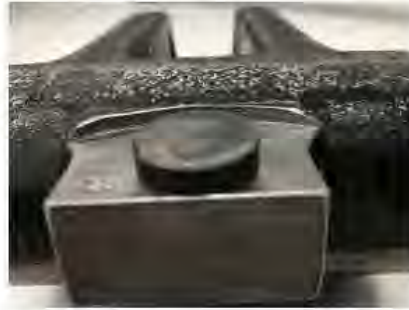
Figure 2: Brake Lever (AAA288AAG2) with Hardened Bearing Button
