**OIL PIPELINE RUPTURE
Sun-Canadian Pipe Line Company Ltd.
8 Inch Line, Mile Post 1.044
Sarnia, Ontario
September 10, 2013**

SR# 1175446

Pipeline Occurrence Report

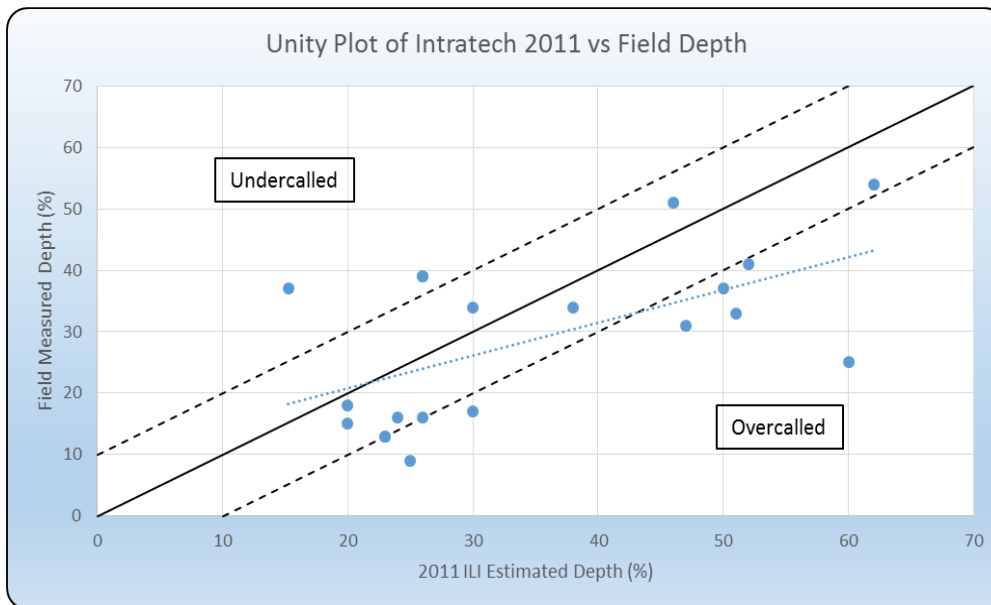
The following is a summary of the unity plot for this run and the five most significant features from this evaluation. This indicates that there are no features that would fail a hydro test at the reduced operating pressure (1.25 x 6960 kPa). The following features located at 55926.08 m, 25273.46 m, and 11885.15 m will be excavated and repaired prior to operation.

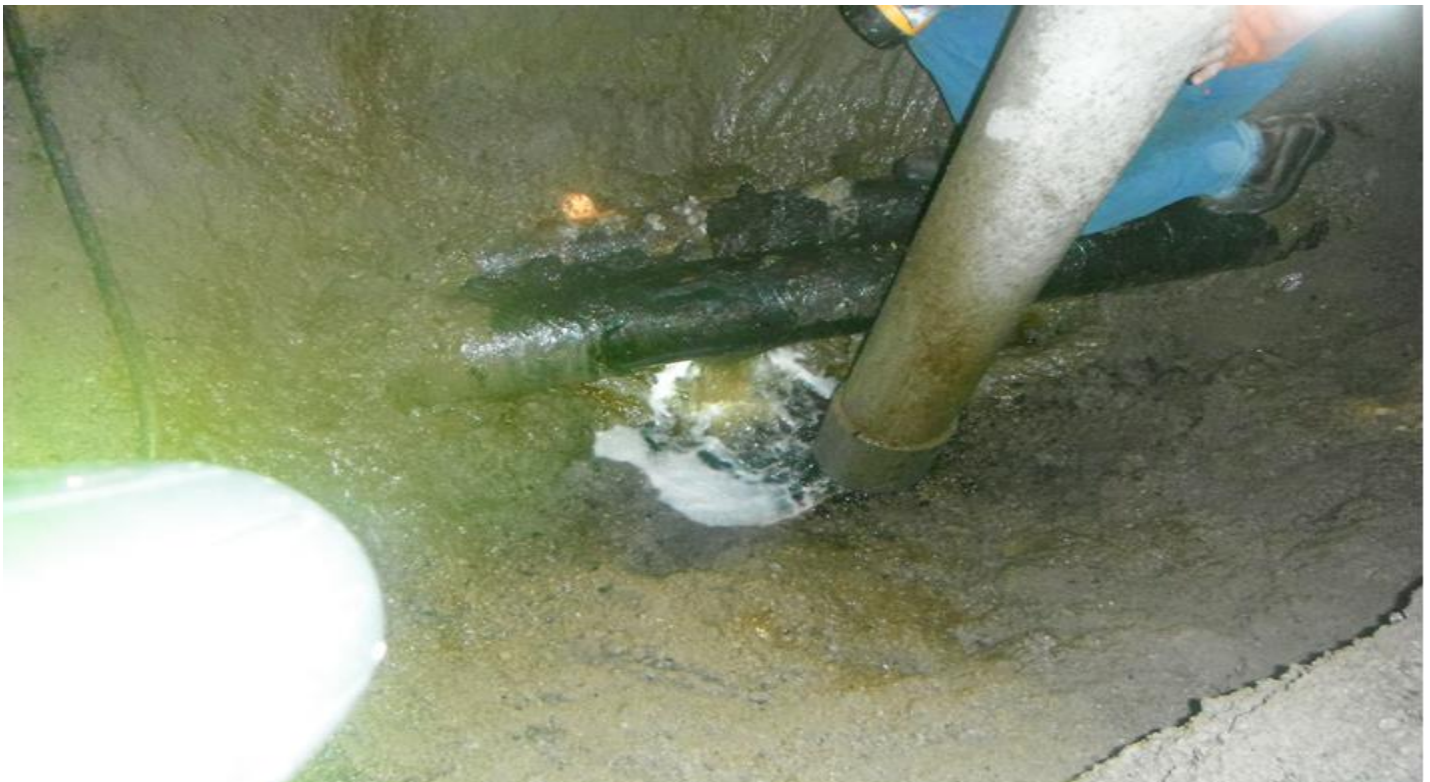
Appendix D: Photo of Pipeline Rupture Site

Damage to the 8" line consisted of approximately 6" (150 mm) of ruptured pipe which had split open in the longitudinal direction, approximately in the five/six o'clock position.

Immediately downstream of and adjacent to the occurrence site, the SCPL pipeline system is in very close proximity, paralleling the 8" line, an abandoned NPS 6 steel Cabot Canada Ltd. (approx. 2 inch apart, as shown in the image found in Appendix D).
