Elevating and Amusement Devices Safety Program	Ref. No.: 307-25
Director's Safety Order	Date: February 21, 2025

Re: Smartrise SRA (V3 CEDES) Controllers with single door zone sensor

**Technical Service Bulletin**

In Reference To: Version V3, failure to detect DZ Stuck High/Low

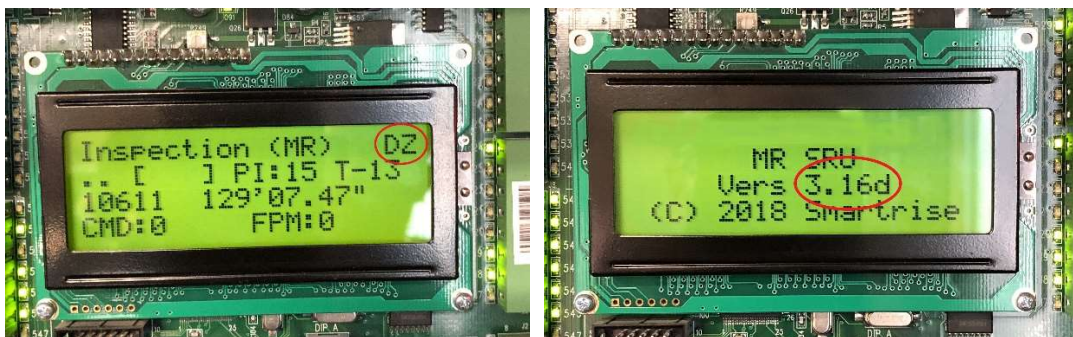
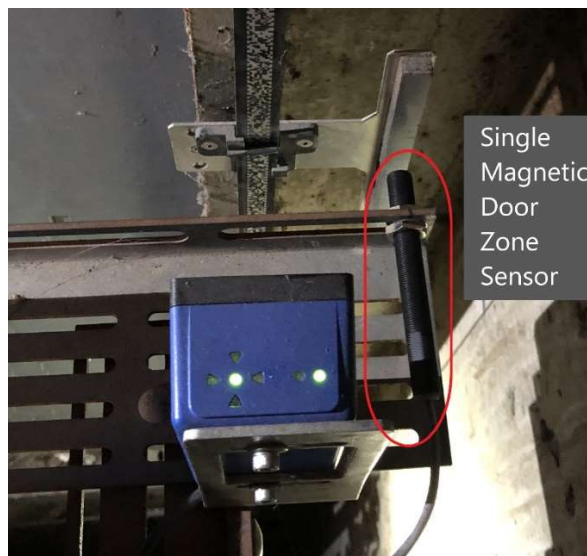
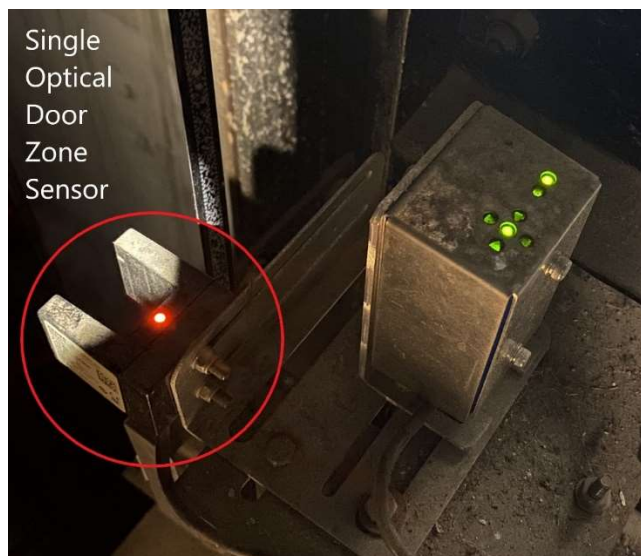
The software version and status of the door zone sensor can be viewed on the main Car Status screen. The Door Zone "DZ" signal should change state as the elevator moves through the Hoistway. Software versions installed on the main controller in the machine room (MR SRU), car operating panel (COP SRU or CAR SRU 1) and car top or COP (CT SRU or CAR SRU 2) control boards (SRU Boards) should be the same software version with V3.18(c) or newer displayed.

2.3 Elevators having a software version prior to version V3.18(c) shall have their software altered to version V3.18(c) or newer and a Minor A Alteration Design Submission submitted in compliance with section 3 of this order prior to **December 1, 2025**.
