| <b>Elevating and Amusement Devices<br/>Safety Program</b> | Ref. No.:<br>281 / 19 |
| <b>ADVISORY</b> | Date:<br>September 5, 2019 |

**Subject:** Turnbull Spring Hitch  
**Distribution:** TSSA website

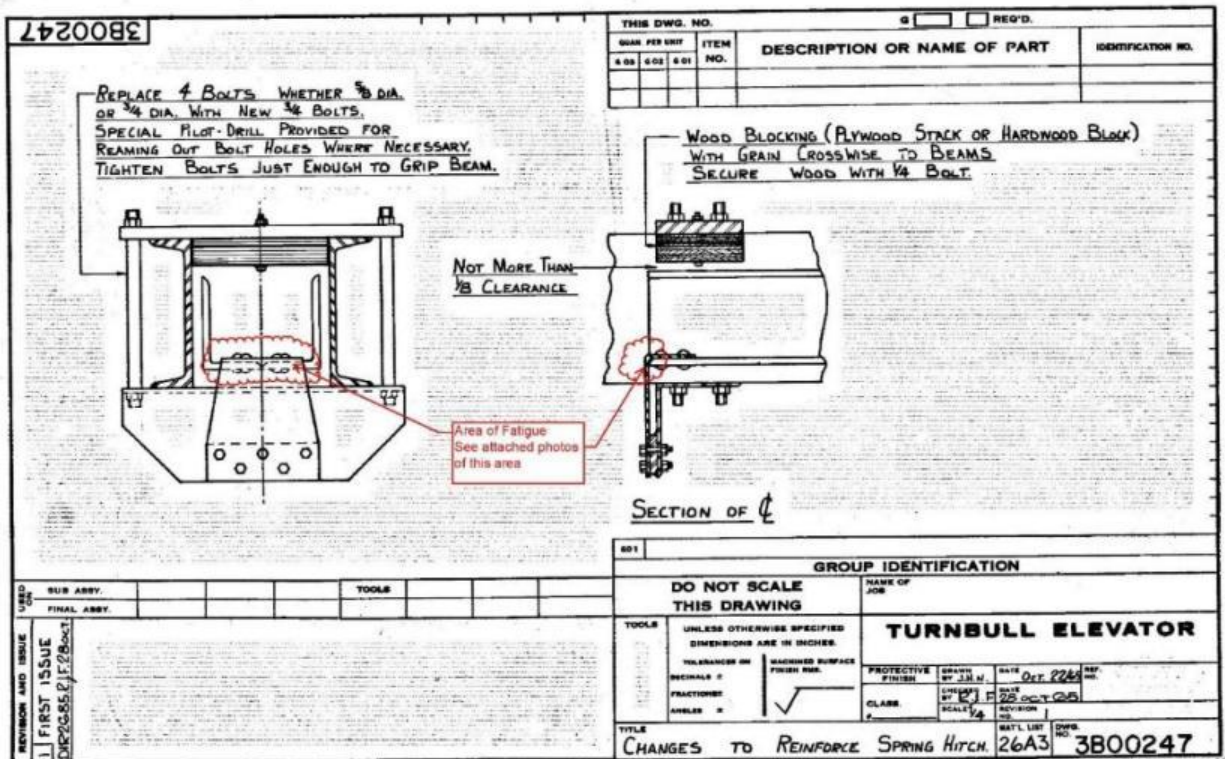
An area of fatigue is identified in the drawing below, and its integrity should be routinely assessed.

This failure was recently observed during a period inspection, and contractors and mechanics should be aware of this issue.

In a 1965 Turnbull letter to the then Department of Labour, Turnbull advised about replacing bolts and adding wood blocking as shown in drawing 3B00247 above.

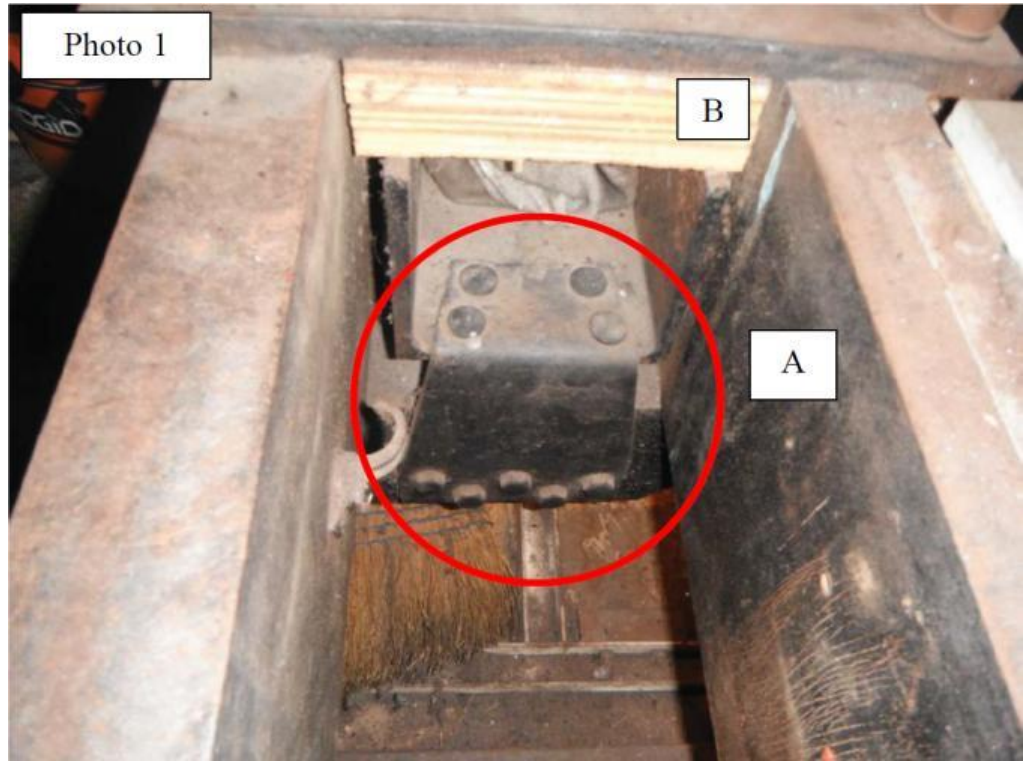
Photo 1  
Showing  
intact spring hitch [A] and  
wood blocking [B]

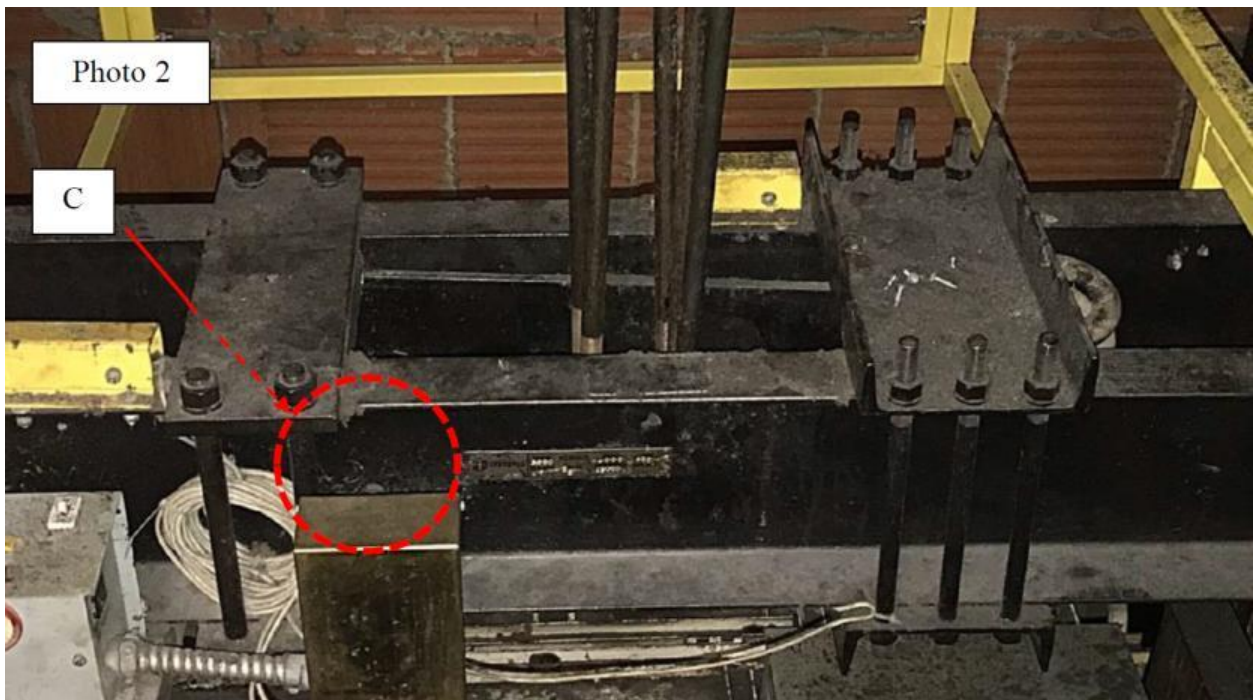
Photo 2  
Overview of spring hitch arrangement

[C] Area where spring hitch is located - between crosshead members (not visible in photo)

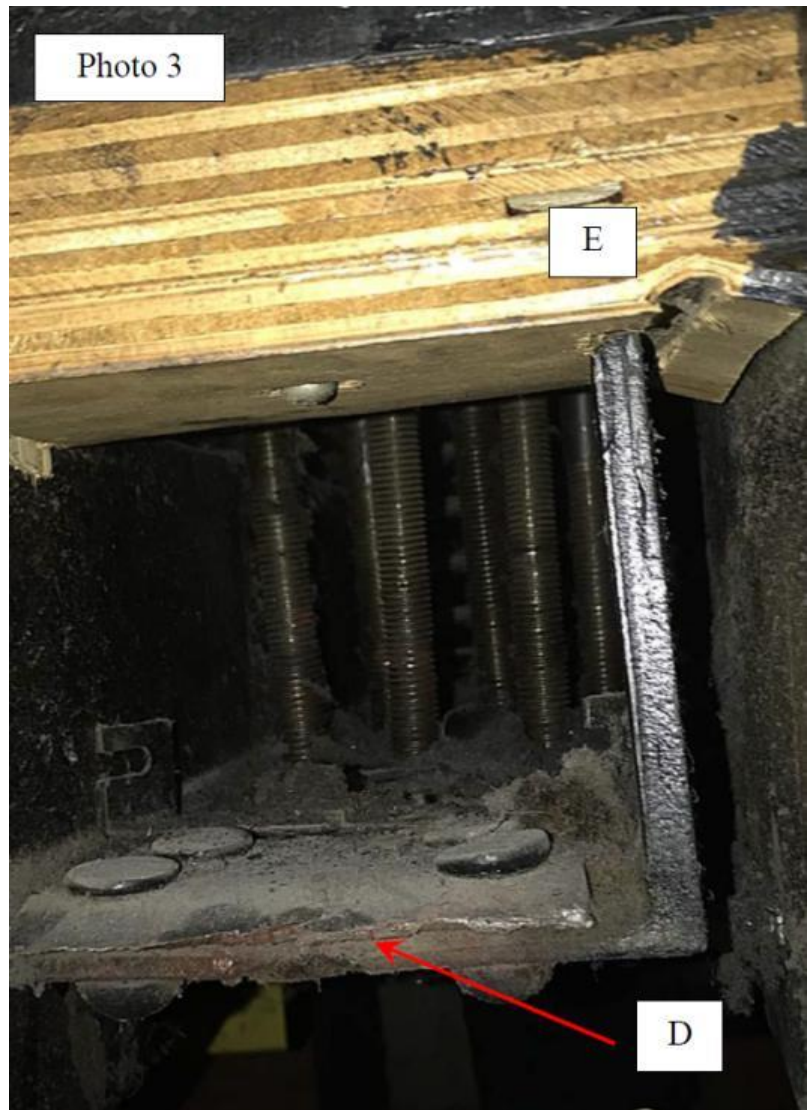
Photo 3

[D] Showing failed spring hitch

[E] Inverted 'C' Channel has embedded itself in the wood blocking (added per Turnbull drawing 3B00247)
