Elevating and Amusement Devices Safety Program	Ref. No.: 302 / 23
DIRECTOR'S SAFETY ORDER	Date: May 18, 2023

Re: Bearings on all Dover-Turnbull Counterweights with 2 to 1 Roping

TKE FIELD BULLETIN 3 JANUARY 2023

Subject: Counterweight assemblies with 2:1 roping.

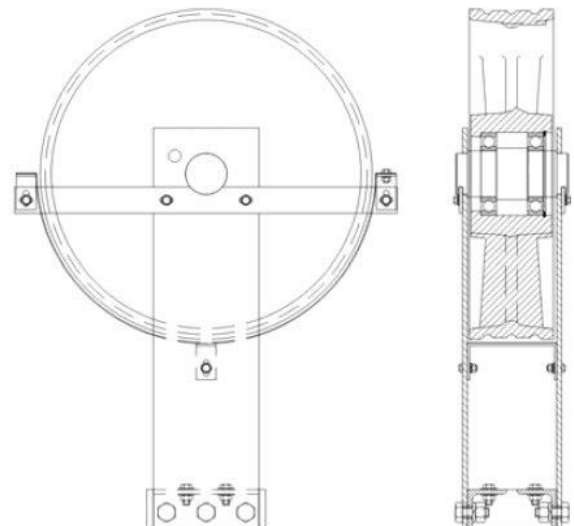
Most Bearings are sealed and lubricated for the life of the bearing. On good bearing the grease retainer shield must be intact, and no grease should be observed coming out of the bearing.

The running clearances on the front and back of the sheave should be the same dimension, different clearance may indicate bearing wear.

- If you are satisfied that the counterweight sheave is in good condition, sign the log off to indicate the inspection is complete and follow the “REPORT OF FINDINGS” procedure.
